How the White River Works and Why it Threatens SR 410

Cross-section of the White River and SR 410 (milepost 58.45 near Mount Rainier)

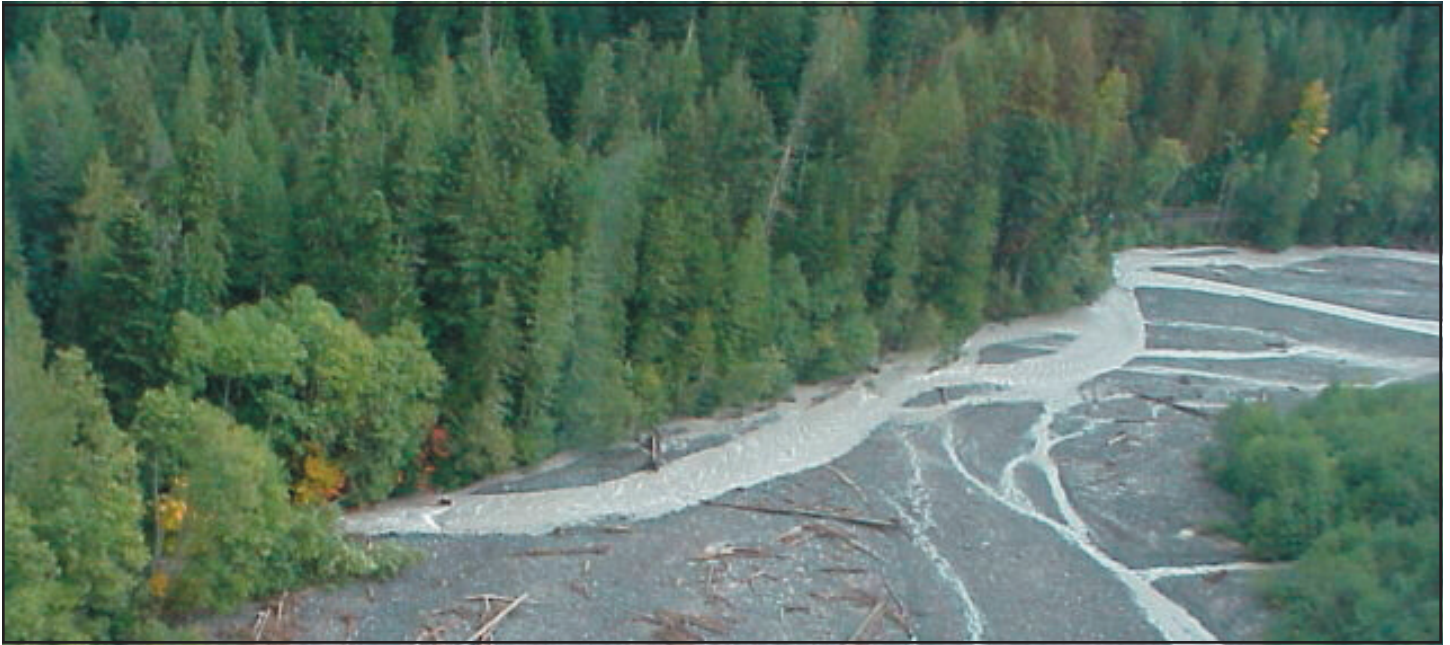
White River channels can rapidly change course, particularly when water levels are high. This photo was taken in 2003, when the river dove into the old-growth forested floodplain and flooded the highway behind the trees.

In 2003 the river dove into the forested floodplain, carving new side channels into the old-growth forest and eventually winding down onto State Route 410. Working in consultation with the National Park Service, WSDOT maintenance crews constructed a temporary gravel dike and placed woody debris between the river and the forested floodplain to redirect the water away from the road. Over time the dike and debris was washed away so WSDOT maintenance installed a more permanent cement block dike covered with river rock in the summer of 2005. More woody debris was placed in the fall of 2005 in the same area. For now these fixes are protecting the highway.
